Hunting PCIe Jitter

A real world example

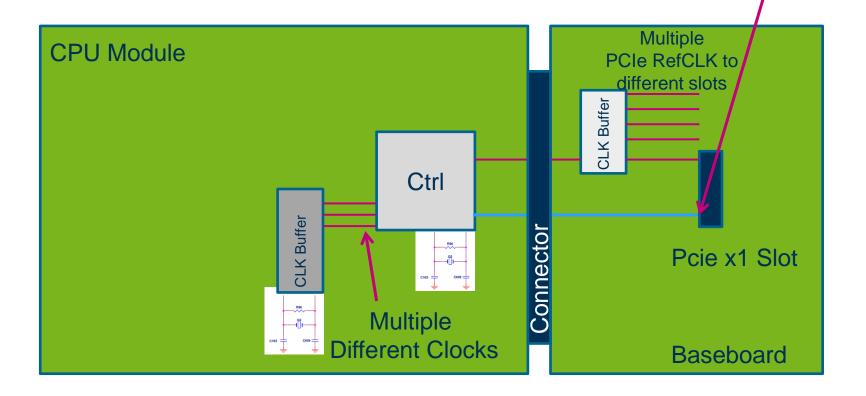
Start to check signal quality at PCIe Slot!

Fail measured here!

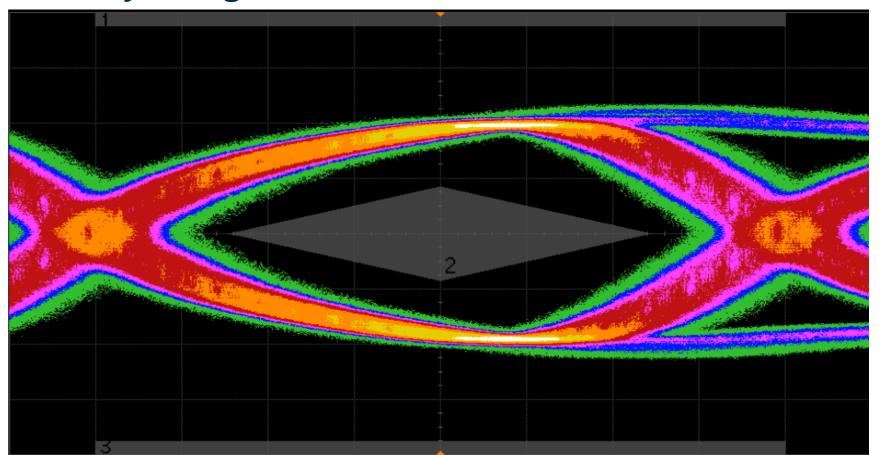
Eye diagram for Transition bits

- Problem is not related to De-Emphasis settings as both eyes are similar bad
 - In case the De-Emphasis Eye Jitter would be much worse as the Transition bit eye the De-Emphasis setting need to be optimized
- Even the fail was marginal there was a big difference in eye quality to a reference system!
 - So even if the test would have passed the difference should have been investigated!

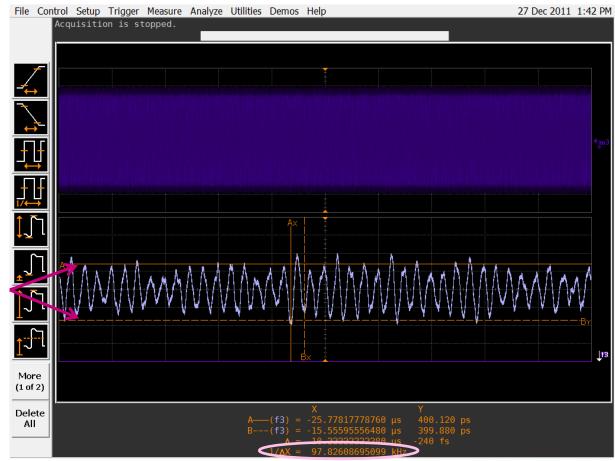
The UI Time trend shows a "strange" modulation of

the UI width.

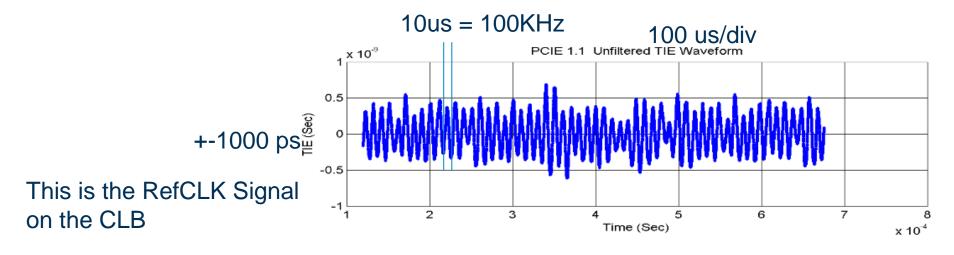
On the TIE jitter Time Trend we see again the 100KHz "Modulation"

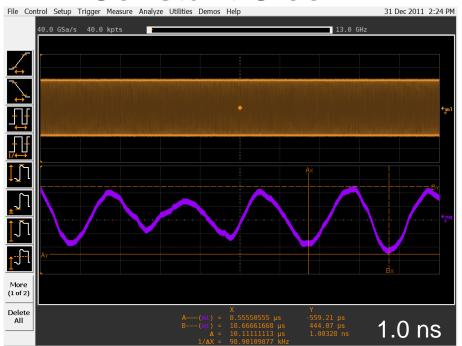
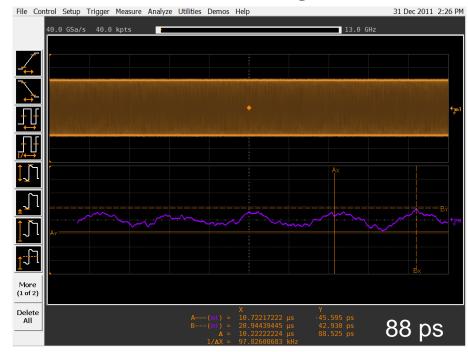
TIE RefCLK on CLB 100MHz (tCK = 10ns)

Success: 100KHz Jitter also found on RefCLK!

Filtered: 88ps Error on a Clock with 10ns tCK

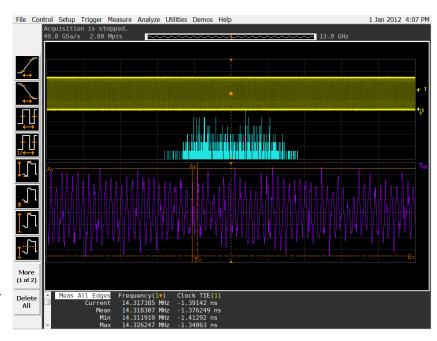
- Min Frequency: 14.311 MHz (Spec: 14.317 MHz)
- Max Frequency: 14.326 MHz (Spec: 14.319 MHz)
- ~ 1.5MHz Modulation

As no relation to 100KHz is seen we stopped at this point to check the crystal performance

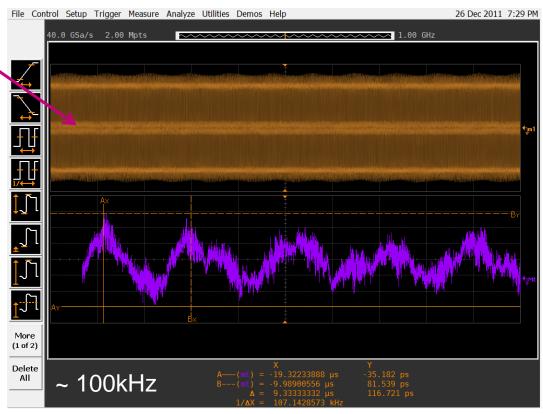
Difficult Measurement, but 100KHz found again!

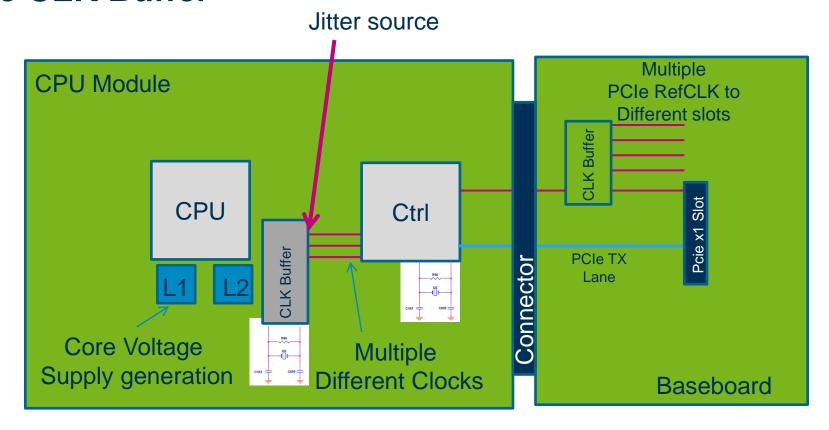
Core Voltage supply inductors are very close to the CLK Buffer

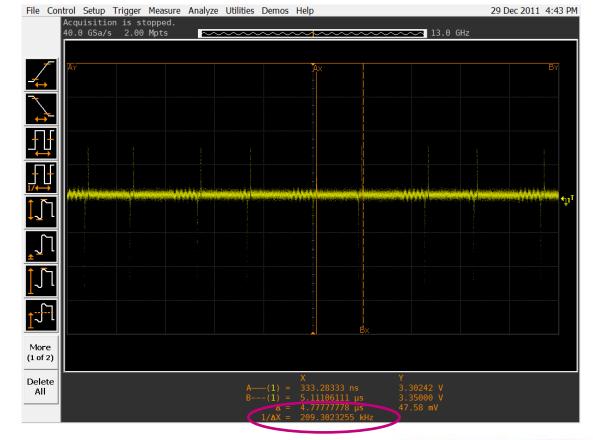
Shot in the Blue .. But 200KHz does not fit to our Problem ..

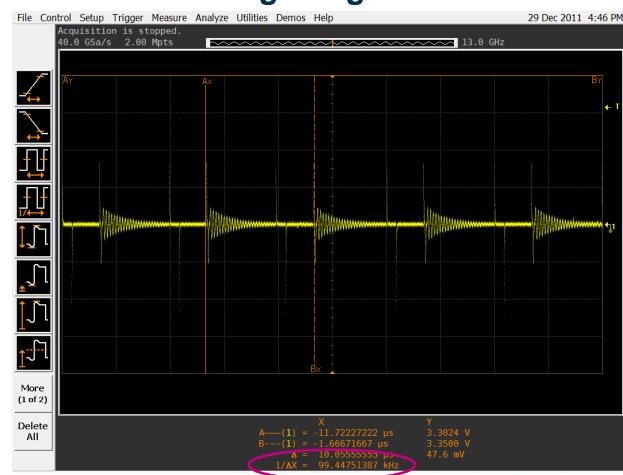
Emission above ISL62391 Voltage Regulator: 100KHz!

Regulator is far away .. But seems related to the Problem!

- **Options for improvement:**
 - Adjust output Capacitor for Voltage Regulator
 - Optimize Ferrite Bead filtering of PLL input
 - Disable DCM mode

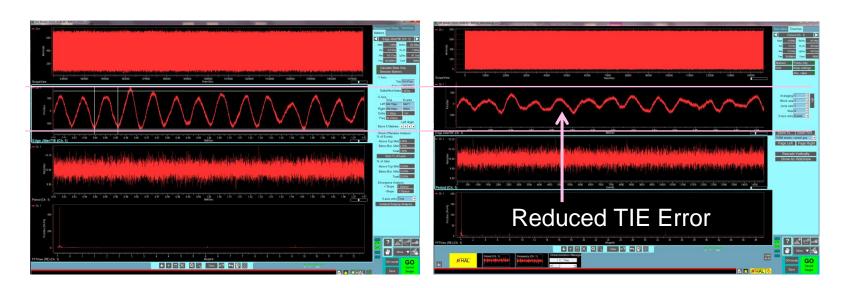
TIE improvement 1 by adding 2x 47uF at ISL62391 out

New Vdd Ck Vdd with additional 2x47uF Cout on V33S

LC on the Regulator output can be optimized!

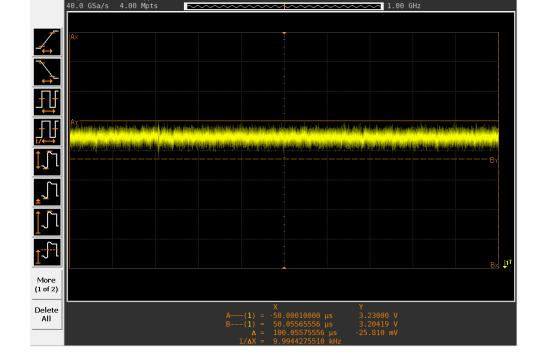
Supply Voltage after Resistor Filter

250 kHz are filtered well!

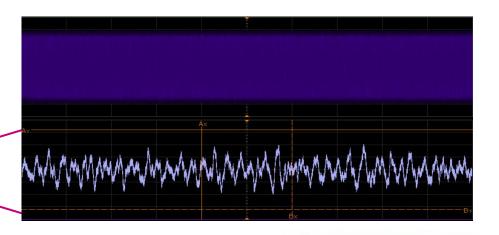
Improved Result

- Ul Time Trend comparison with all changes
 - Quite some margin in the TX UI Time Trend
 - There might be some more Improvement possible, but TX compliance test passes.
